Type A Accident
Investigation Report
of the
June 25, 1997
Contract Inspector Fatality
on the
Satsop-Aberdeen #2 & #3
230 kV Line

B O N N E V I L L E
POWER ADMINISTRATION

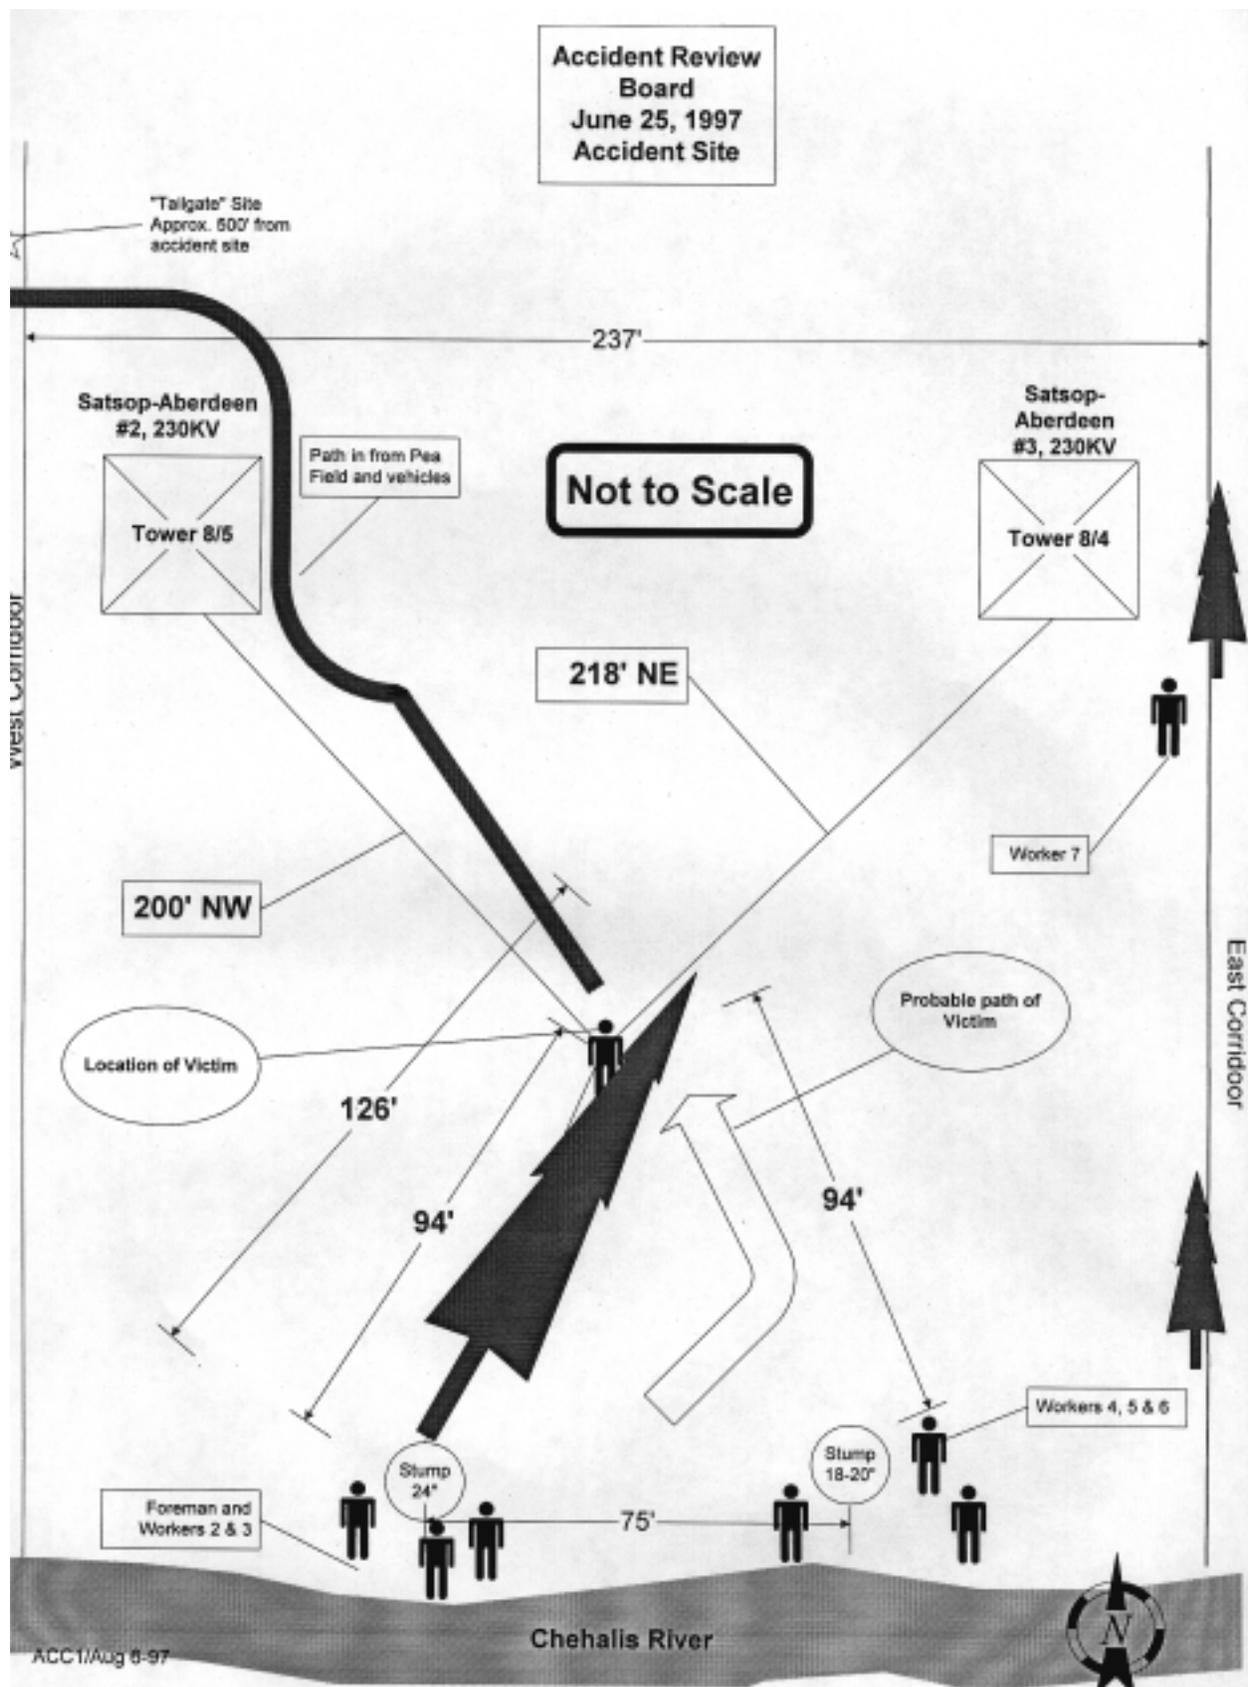
Figure 1 - Sketch of Accident Site

The accident site is located on the Satsop-Aberdeen #2 and #3 230-kilovolt (kV) line right-of-way (ROW), about 200 feet southeast of structure 8/5 (fifth structure in the eighth mile) on the Satsop-Aberdeen #2 and 218 feet southwest of structure 8/4 (fourth structure in the eighth mile) on the Satsop-Aberdeen #3 out of BPA's Satsop Substation, located south of Montesano, Washington. The ROW is located on BPA-owned property. Back-on-line (BOL) approximately 337 feet is the Chehalis River (See Exhibit 1 and Fig. 1). The corridor width is 237 feet. These dimensions encompass the overall area of the work location and accident site. The contract work in progress was part of an overall project that included significant brush cutting, vegetation control and tree falling within the ROW along the entire length of the two transmission lines (See Exhibit 2).

At the time of the accident, seven CORRUCO employees were performing the following work at the accident site: Three brush cutters were working on removing limbs and brush from a tree that had been cut and had fallen into the river; the foreman and two additional employees were approximately 75 feet west at the base of a 126-foot cottonwood tree; and another employee was located adjacent to structure 8/4, approximately 100 feet northeast of the accident site.

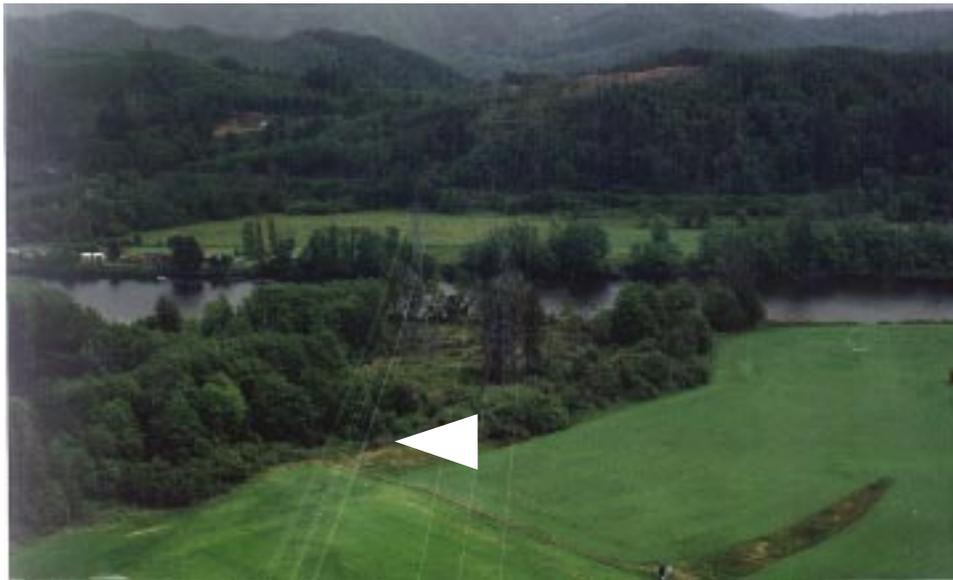
Exhibit 3 - Tailgate Site

A “tailgate” instructional meeting, attended by all CORRUCO employees and the Cinnebar inspector, was conducted on the morning of June 25, 1997, before the accident and prior to work commencing (See Exhibit 3). The results of the statement process and meetings with each individual CORRUCO employee revealed that the foreman spoke only Spanish and broken English; the remaining CORRUCO employees spoke Spanish only. Acting in his role as overseer of work to be accomplished and of quality assurance, the inspector told the CORRUCO foreman what needed to be done: clearing brush and trees within the right-of-way (ROW) work area. The foreman then translated for the brush-cutting crew, informing them of their assigned tasks. Specific details of the actual discussion are not available.

A "tailgate" instructional meeting, attended by all CORRUCO employees and the inspector, was conducted on the morning of June 25, 1997, before the accident and prior to work commencing (See Exhibit 3). The inspector was not able to confirm, or did not ensure, that workers fully understood their work assignments, safety requirements, and acceptable work practices; nor did the inspector verify that safe work processes were being implemented at the job site. Safety measures failed because the inspector was not aware of, or ignored, tree-falling work methods being used.

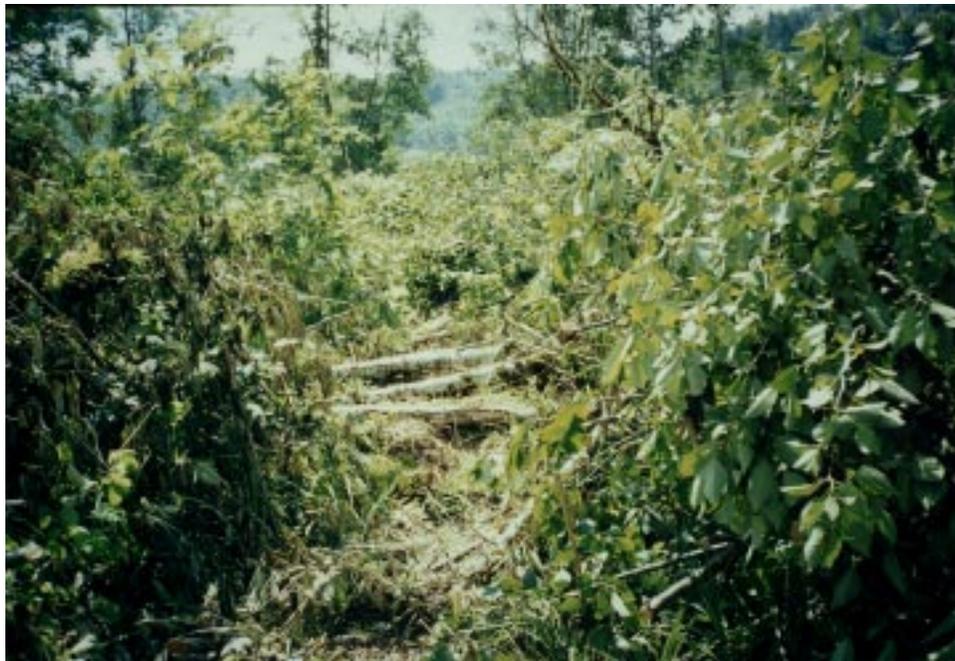
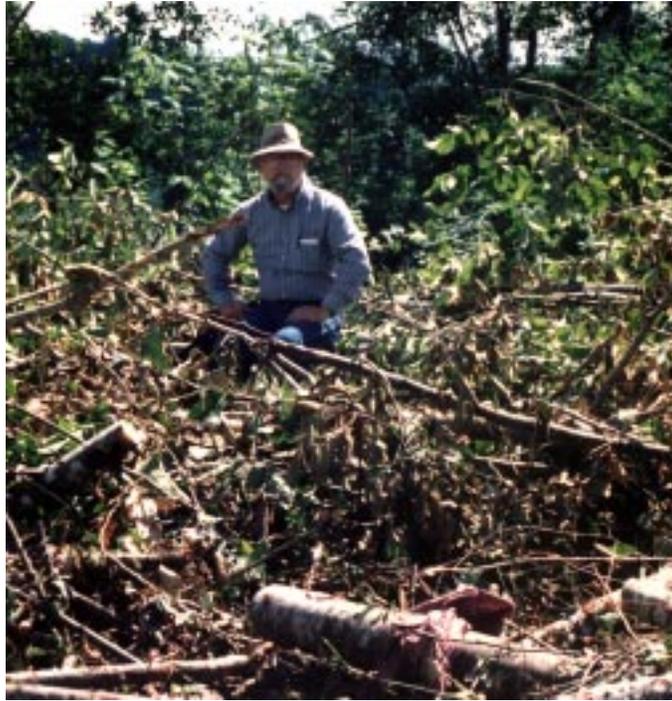
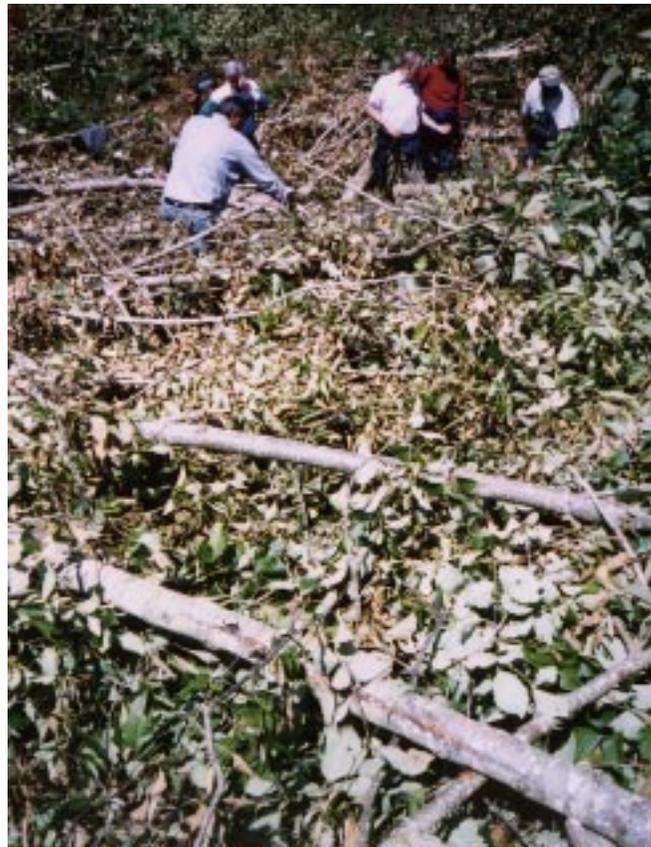
Exhibits 8, 9 & 10 - The Inspector's Probable Path Toward the Fall Line of the Tree.

previously overlooked trees and brush by structure 8/4. Subsequently, the inspector and the brush cutter walked together, with the brush cutter slightly ahead of the inspector. Both proceeded eastward, away from the cottonwood tree. Then the inspector turned and headed north-northwest, toward his truck and the path leading into the work zone, through the previously cut brush and trees. This was in the path of the cottonwood tree to be fallen (See Exhibits 8-10). The brush cutter turned north, parallel with the east corridor tree line, to the area that needed cutting adjacent to structure 8/4.

- The inspector, walking through the tree-cutting area, failed to maintain the required minimum distance between himself and the tree being fallen.
- The inspector failed to communicate and coordinate his location with the tree faller.

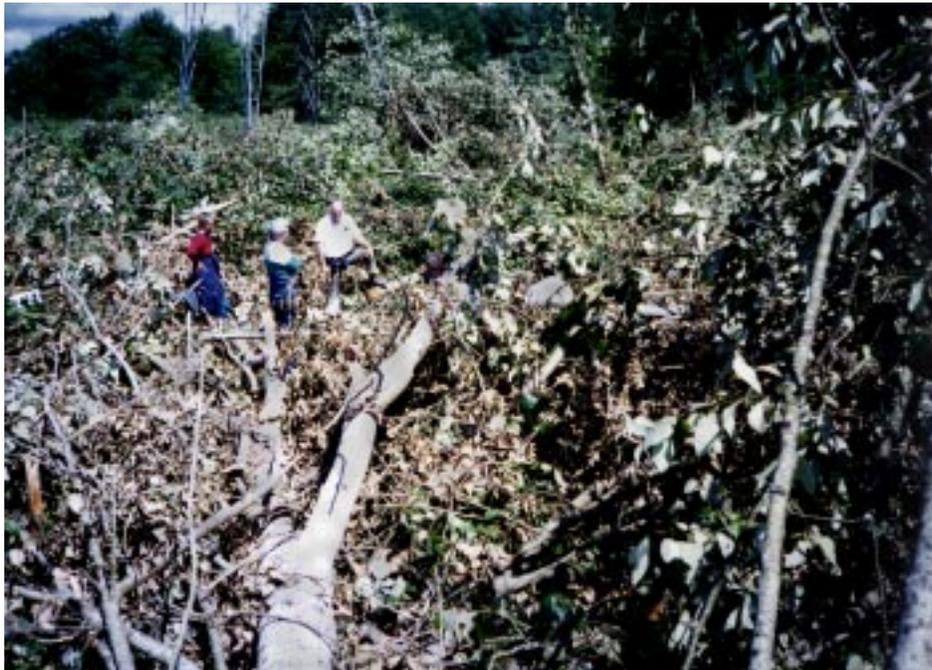
Exhibit 13 - Accident Spot

Statements indicated that, 15 to 20 minutes after the foreman and inspector had spoken, the foreman started to cut the cottonwood tree. The time elapsed coincides with a reconstruction, by two investigators, of the inspector's movement along the path from the work area, leaving the site where the foreman and the inspector had met and traversing the probable path to the accident location. The extreme density of the uncleared, cut brush and trees contributed significantly to this seemingly prolonged interlude. The foreman made his initial face cut, and, according to his statement, stopped and looked over the fall area to make sure no one was there. The presence of thick brush and previously downed trees prevented the foreman from seeing all of the fall area. Nevertheless, he promptly proceeded to make his back cut. Upon completing this final cut, the foreman shut off his saw and yelled "TIMBER," in English, and "TREE FALLING" in Spanish. Concurrently, the CORRUCO employee adjacent to structure 8/4 called out "Inspector in the area, I can't see him." (See Exhibit 11.) After the tree had fallen, the foreman immediately jumped up on either the cottonwood tree butt or tree stump (he isn't sure) and called out to the inspector several times (See Exhibit 12). According to the foreman's statement, the inspector responded "Here! Here!" Hearing this response, the foreman proceeded approximately 65 feet down the fallen tree and saw the inspector, about 30 feet away, among the tree branches and limbs (See Exhibit 13).

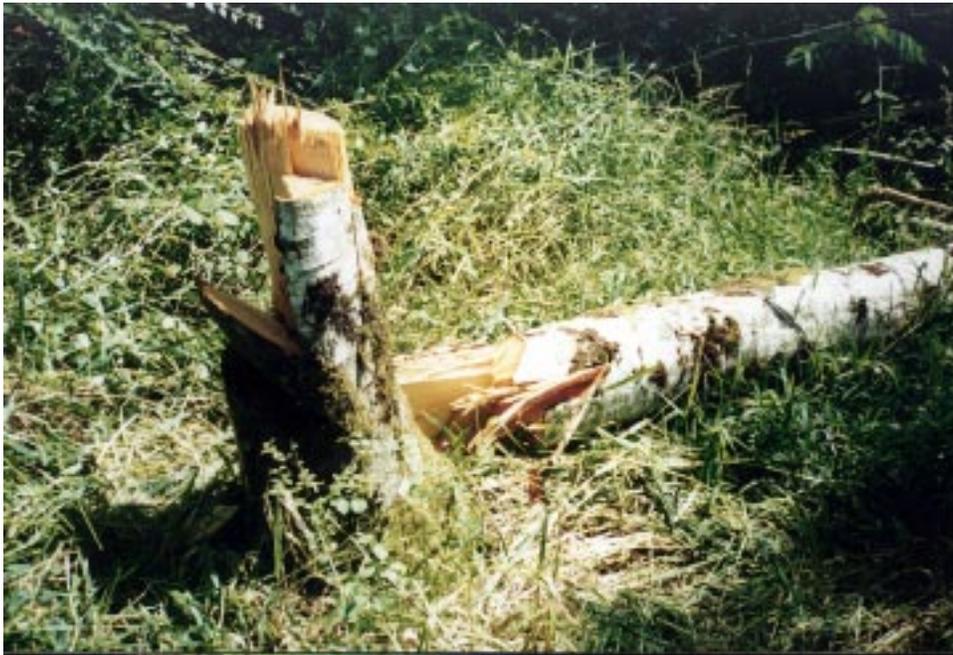
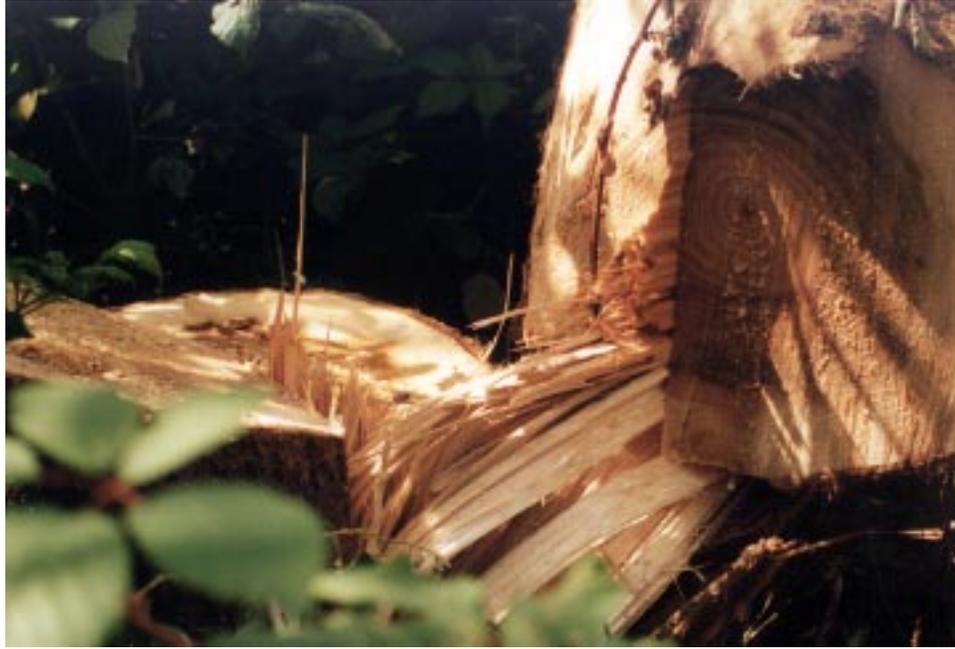
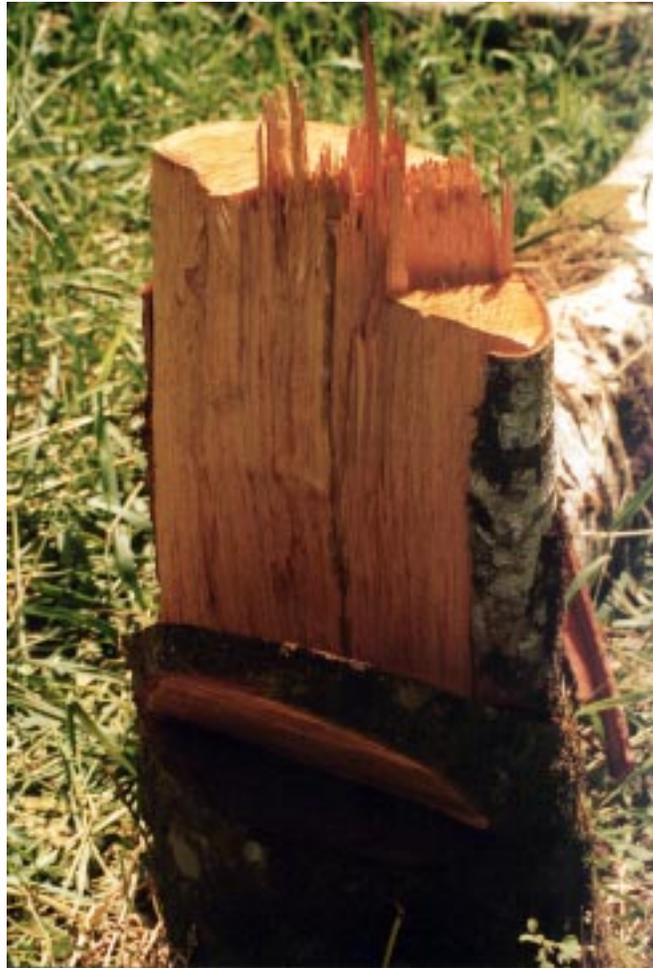
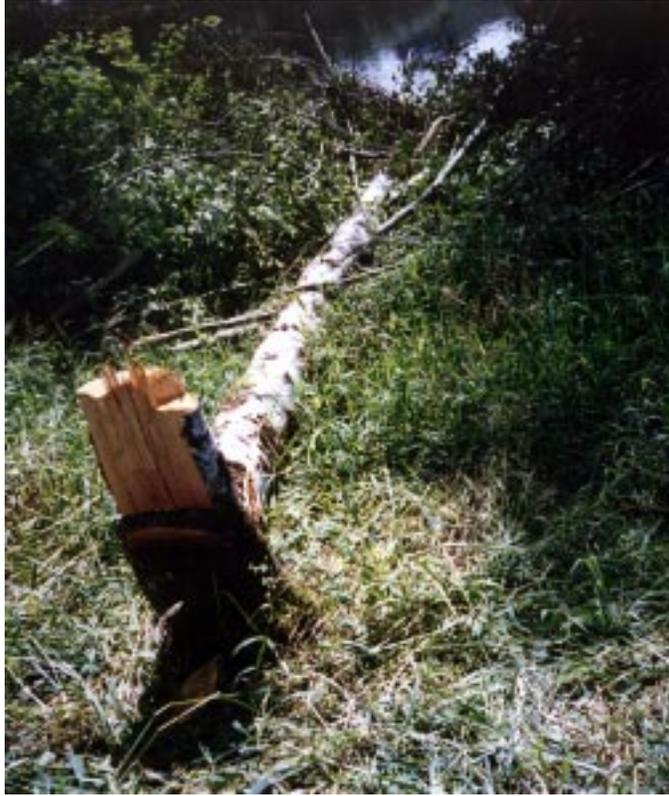
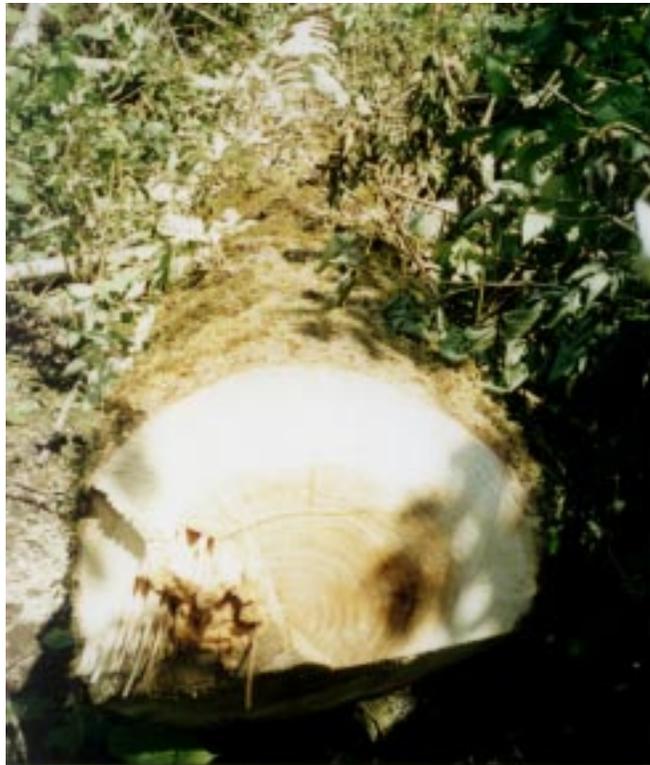
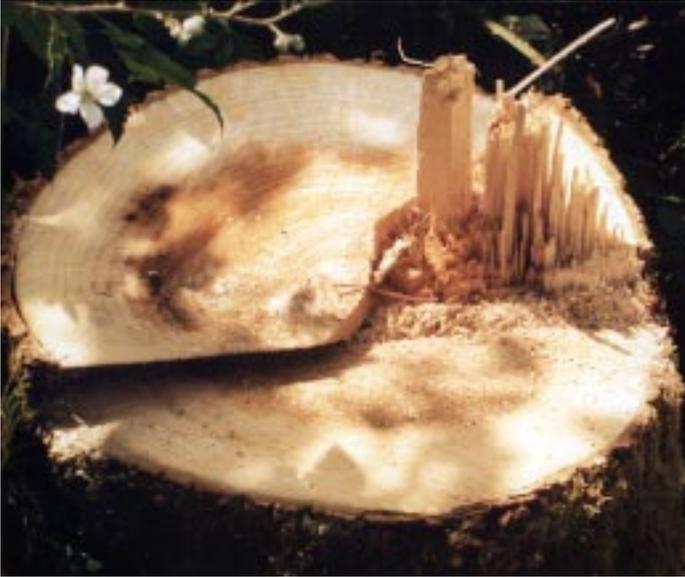
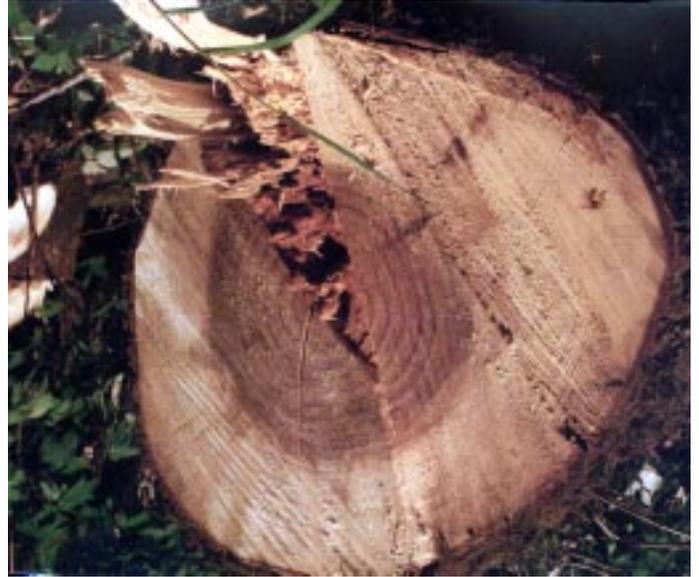
Exhibits 16-22 - Improper Cutting Methods

- After the initial face cut is made, the faller should shut off his saw and make a final, visual observation of the fall area (See Exhibits 16-22 for improper tree-falling examples). He should obtain full assurance from vocal responses that no employees are in the work/fall area; employees should respond to the faller with their exact location. The faller should know how many employees are involved and compare that figure to the number of responses he receives.

<ul style="list-style-type: none"> • The crew was not adequately trained to recognize the hazards involved in tree-falling operations. • Due to lack of training and poor tree-cutting techniques, each of the larger (>30') trees fallen represented a potentially fatal threat. • No training records of worker qualification for tree falling were available. • Only properly trained and experienced employees should be permitted to cut larger (>30') trees. 	<ul style="list-style-type: none"> • Clearly outline and verify the qualifications and training required to safely accomplish the tasks. • Distinguish the different qualifications required for brush cutting and tree fallers. • Employ an adequate ratio of qualified tree fallers to brush cutters, a safer and more efficient process than splitting up the tasks into two separate contracts.
<ul style="list-style-type: none"> • Warning signals, required to be in accordance with federal and state requirements during the falling of trees, were inadequate. • Crew members did not always maintain visual contact with one another during the falling process. 	<ul style="list-style-type: none"> • Verify contractor knowledge, experience, abilities and training records to ensure that the contractor can perform work consistent with all Federal and state regulations governing the tasks outlined in the contract.
